현대 자동차 중국 연구소 CCA BUSBAR 테스트 결과

Copper Clad Aluminum (CCA) Bus Bar Test Report

2020.06.24

Copper Clad Aluminum (CCA) Bus Bar Development

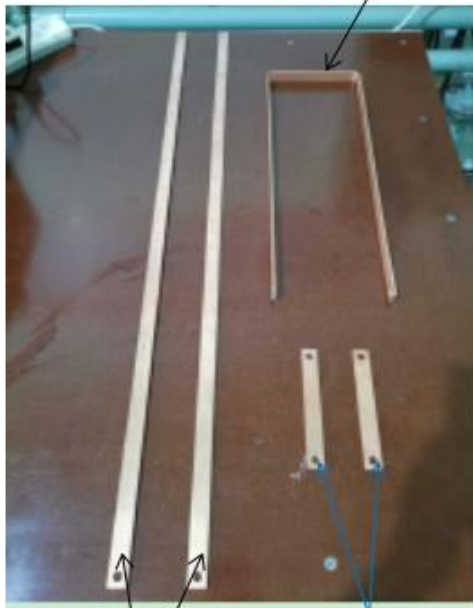
< Before connecting >

Connected CCA bus bar test method

U connecting CCA bus bar

Target CCA bus bar
(for testing)

Connecting CCA bus bar

Compared the temperature rise between ① Cu bus bar and ② CCA bus bar (① Cu bus bar: 20 × 3 × 150mm; ② CCA bus bar: 20 × 4 × 150mm) at the electric current condition of 100A, 200A, 300A and 3 coating types (bare, Sn, Ni), respectively.

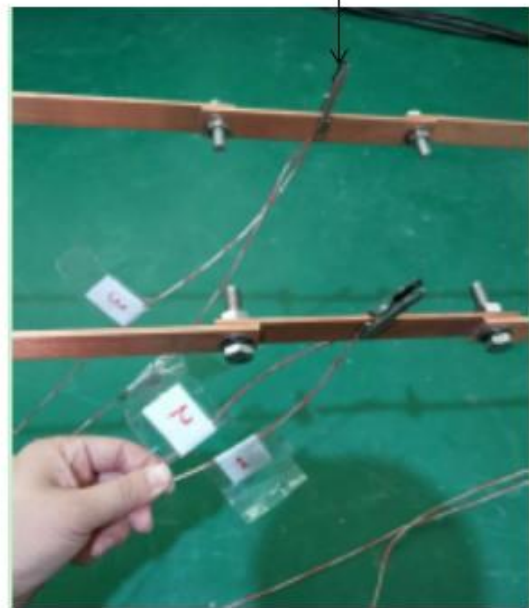
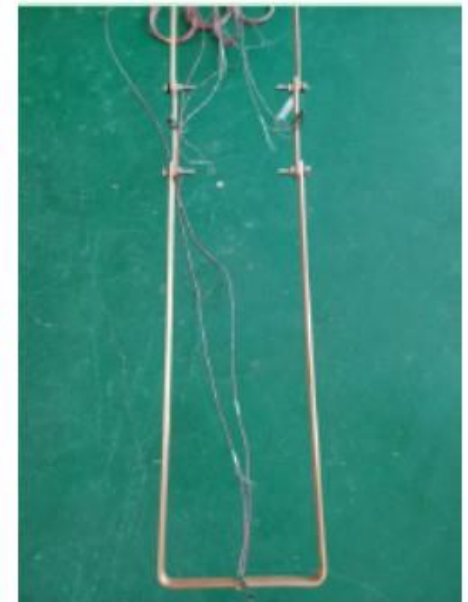
< Connected state >

Thermocouple

According to the results, temperature rise of Cu bus bar and CCA bus bar are in the same level (CCA bus bar is slightly higher)
